SERVICE BULLETIN

BULLETIN NUMBER: 738-0513
MODEL: SDA-1800, SDA-2100, SDA-2300 Steerable Drive Axles
SUBJECT: Upper Kingpin Bore Inspection

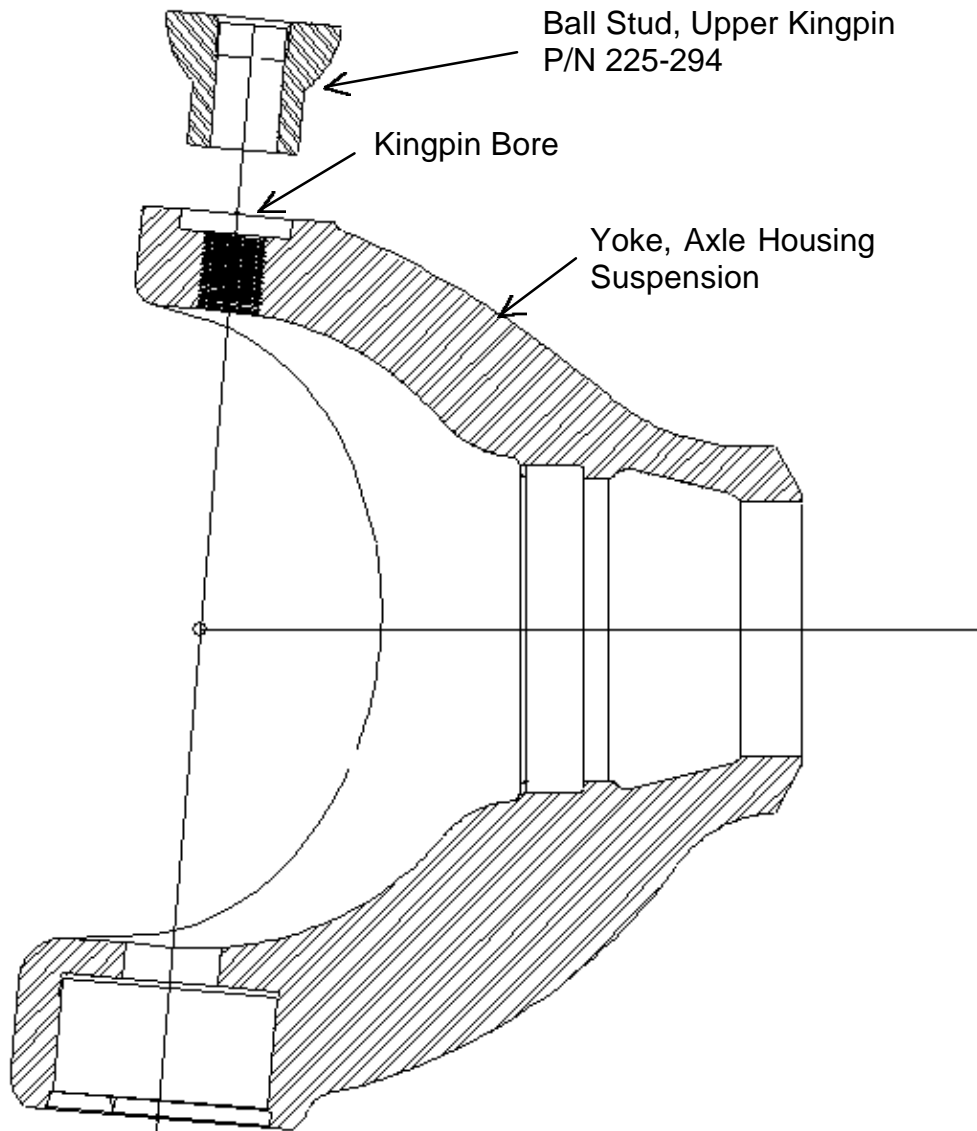
The upper kingpin ball stud has an interference fit in the axle housing suspension yoke (0.001 to 0.004 inch interference). Failure to properly torque the upper kingpin bolt can cause the ball stud to loosen which could damage the suspension yoke kingpin bore.

1. Ensure both the ball stud and suspension yoke kingpin bore are clean and free of debris.
2. Attempt to locate ball stud P/N 225-294 in hole. The ball stud should not slide easily into the hole. Once in the hole the ball stud should not be able to be rotated or moved in the hole.
3. If the ball stud slides easily in the hole evidence of wear in the hole should clearly be visible (e.g. noticeable elongation of hole, burrs at hole edge or "plowing up" of material at hole edge).
4. If the ball stud is loose in the hole the axle housing should be replaced. Contact Fabco Automotive for further assistance.
